**Flood Control Project Maintenance
Levee Inspections**

Maintenance Issue Types Only, Levee Inspection Report By Mile - Spring 2018

Merced Streams Group

Waterway	Bank	Unit Miles	Inspection Start/End	Inspector
Unit No. 01 Black Rascal Diversion	Right	1.61	04/06/2018 04/06/2018	Richard Willoughby

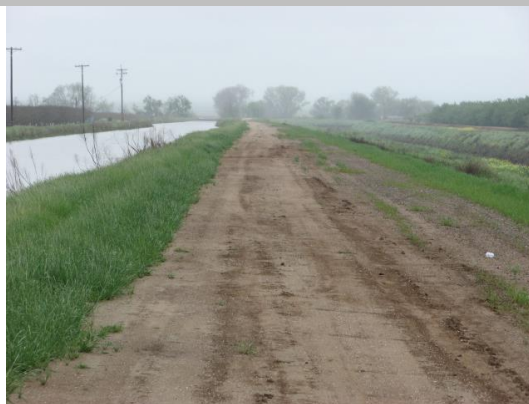
Photo 1 of 1 : SP_2018_NA0013_331_8_20180409_00009.jpg

Looking downstream at typical view of levee crown (Spring 2018)

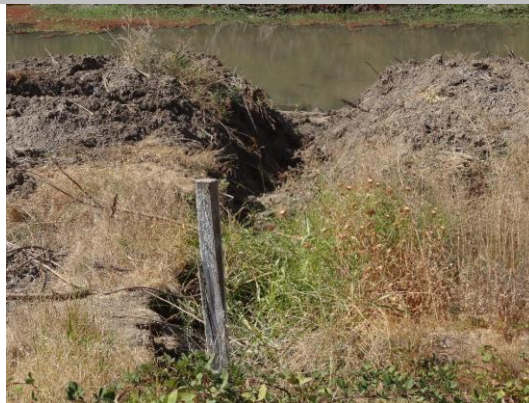
Photo 1 of 3 : UCIP_SP_2018_50156_35245.jpg

WS view: cobble spillway and channel on waterside.

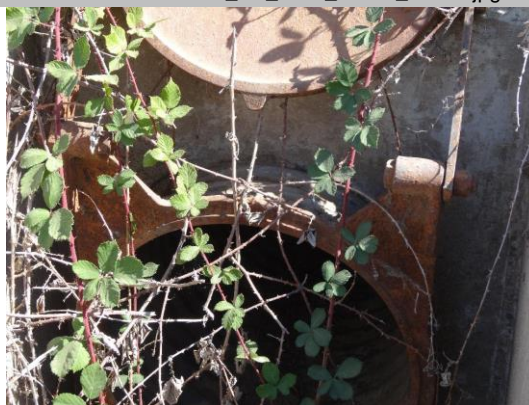
Photo 2 of 3 : UCIP_SP_2018_50156_35244.jpg

WS view: U typed concrete headwall, CM pipe, and flap gate. Flap gate was not closed. Vegetation needs to be cleared.

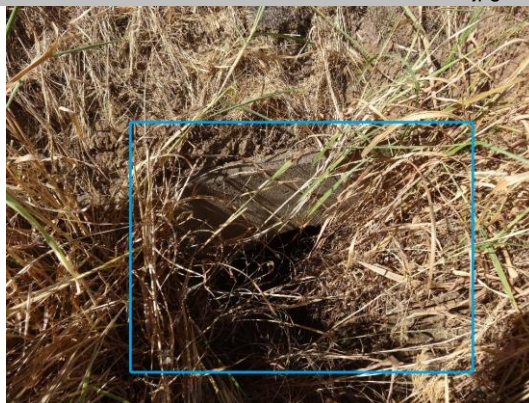
Photo 3 of 3 : UCIP_SP_2018_50156_35246.jpg

LS view: concrete headwall and CM pipe. Inlet needs cleaning.

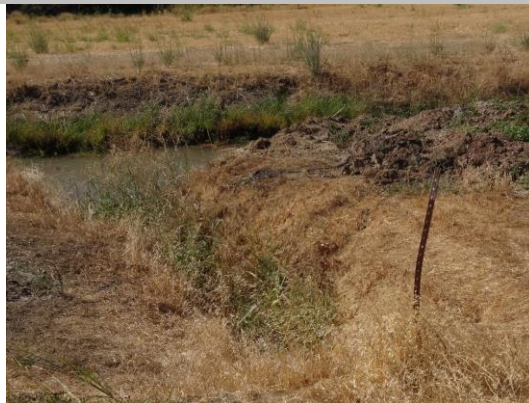
Photo 1 of 3 : UCIP_SP_2018_20946_35266.jpg

WS view: cobble spillway and channel on waterside.

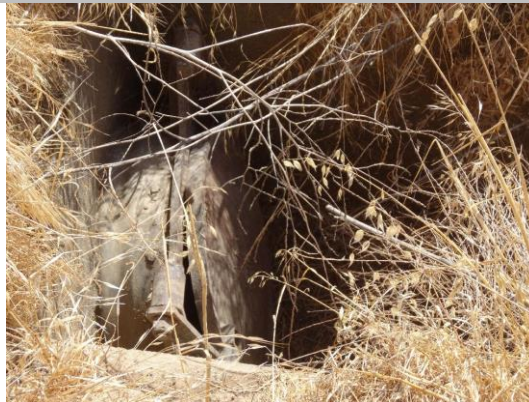
Photo 2 of 3 : UCIP_SP_2018_20946_35265.jpg

WS view: U typed concrete headwall, CM pipe, and flap gate. Flap gate was not properly closed.

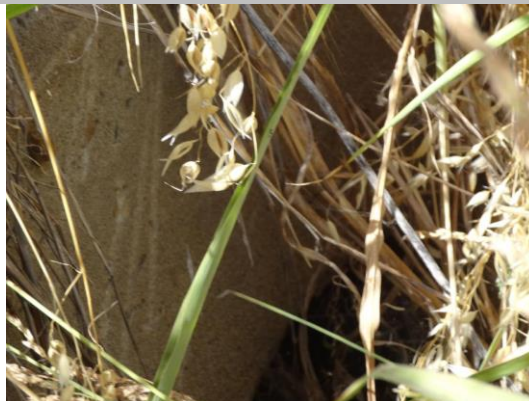
Photo 3 of 3 : UCIP_SP_2018_20946_35264.jpg

LS view: concrete headwall and CM pipe. Inlet needs cleaning.

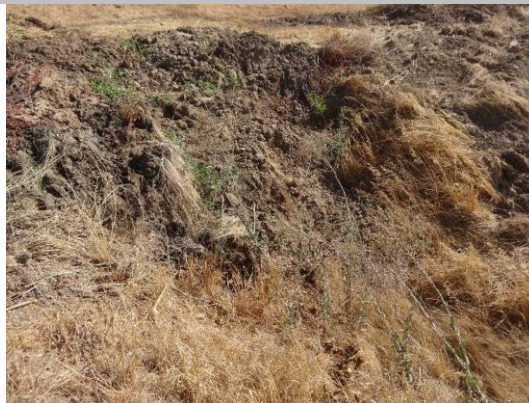
Photo 2 of 3 : UCIP_SP_2018_20992_35369.jpg

FS_ID:20992
DS_ID:23055
EP_NO: N/A
Repair Type: Non-Urgent
Crossing Status: Found
UCIP Comments: - mud and debris from recent channel cleaning needs to be removed from spillway and outlet - pipe filled with debris, it needs cleaning.- half of intet pipe burried.
FIELD_STRUCT_DESC: 24-inch corrugated metal gravity drainage pipe through the levee, 8 feet below the crown. Concrete headwall, flap gate, and concrete grouted cobble spillway on the waterside (WS) toe.
Concrete headwall on the landside (LS) toe. [Additional Reference(s): DWR Levee Log, 2005. USACE San Joaquin O&M Manual 607, June 1962, (HLM 0.73)].
FS Date: 9/17/2013

WS view: debris and mud deposited from the channel cleaning. It needs to be cleared from spillway and outlet structure.

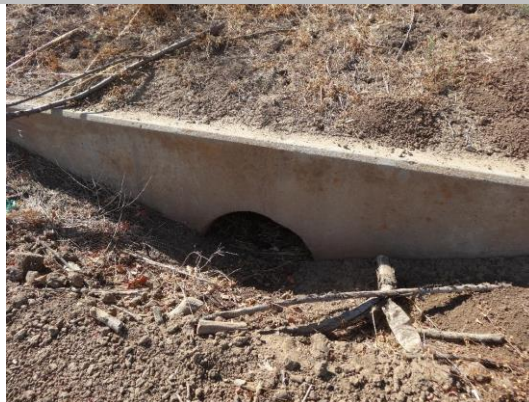
Photo 3 of 3 : UCIP_SP_2018_20992_35366.jpg

LS view: concrete headwall and CM pipe. Half of intet pipe burried.

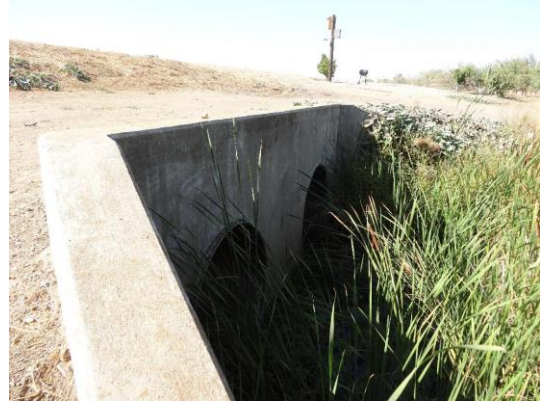
Photo 3 of 3 : UCIP_SP_2018_20965_35290.jpg

LS view: two CM pipes and U typed headwall on levee toe. Green vegetation in drainage channel.

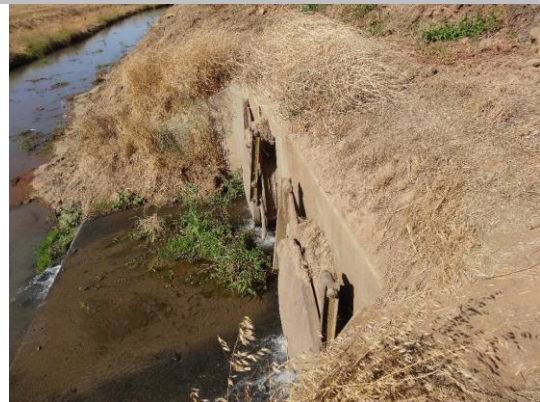
Photo 1 of 3 : UCIP_SP_2018_20983_35302.jpg

WS view: two CMPs with flap gate, concrete spillway and channel on waterside.

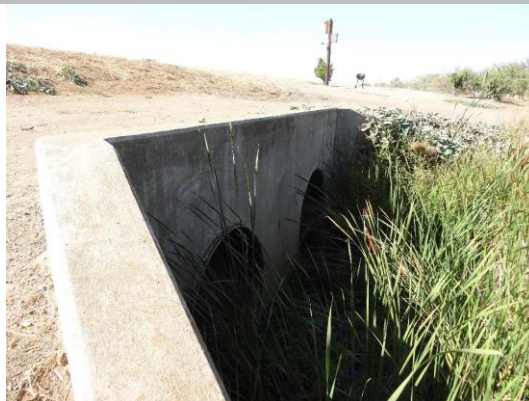
Photo 2 of 3 : UCIP_SP_2018_20983_35301.jpg

LS view: U typed concrete headwall, two CMPs in drainage ditch. Dense vegetation in drainage ditch.

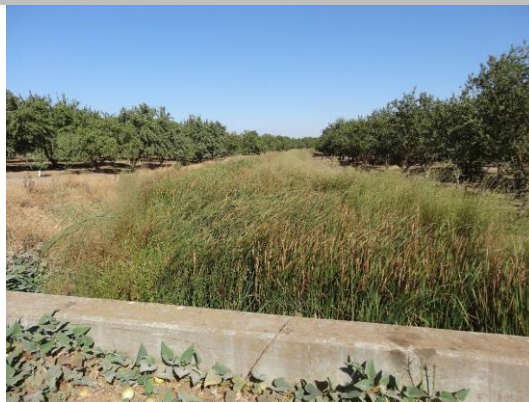
Photo 3 of 3 : UCIP_SP_2018_20983_35300.jpg

LS view: concrete headwall in drainage ditch. Dense vegetation in drainage ditch.

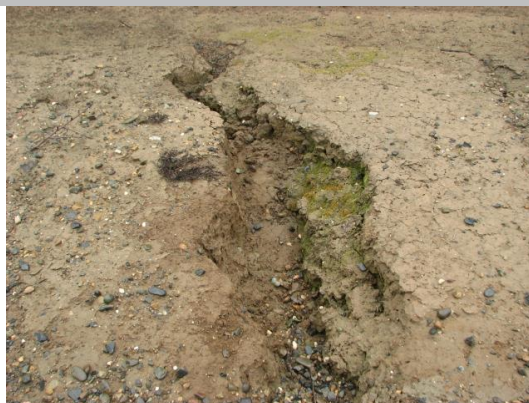
Photo 1 of 2 : SP_2018_NA0013_332_15_20180409_00036.jpg

Looking east at finger erosion on landward slope. (Spring 2018)

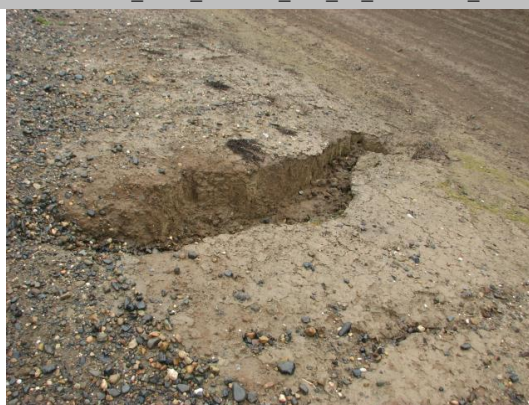
Photo 2 of 2 : SP_2018_NA0013_332_15_20180409_00037.jpg

Looking downstream at finger erosion on landward slope. (Spring 2018)

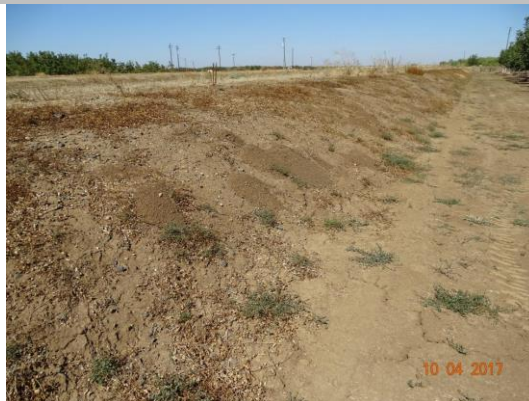
Photo 1 of 1 : SP_2018_NA0013_332_18_20180307_00007.jpg

Rodent activity on LS slope.

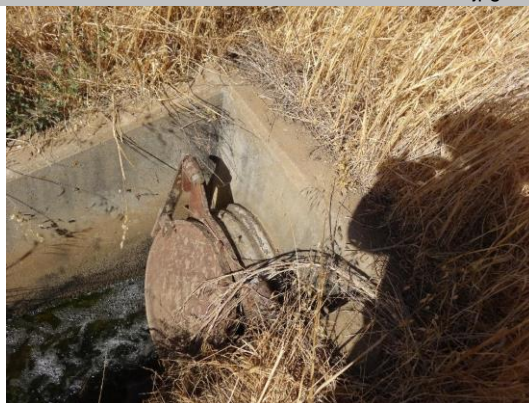
Photo 2 of 3 : UCIP_SP_2018_20984_35304.jpg

WS view: U typed concrete headwall, CM pipe, and flap gate. It was working during field inspection.

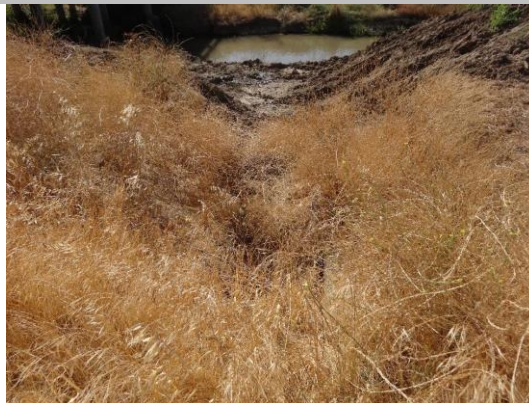
Photo 1 of 3 : UCIP_SP_2018_42993_35310.jpg

WS view: overview of outlet area and channel. Debris and vegetations on spillway.

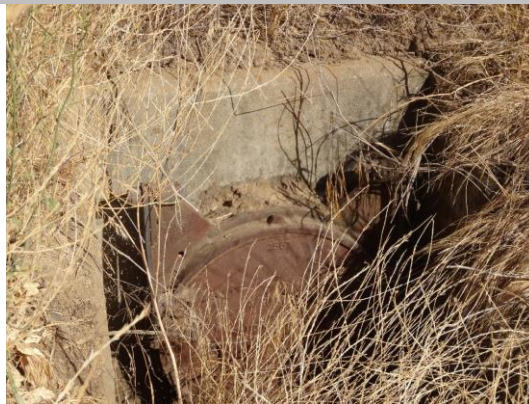
Photo 2 of 3 : UCIP_SP_2018_42993_35309.jpg

WS view: U typed concrete headwall, CM pipe and flap gate. Vegetation and debris need to be cleared.

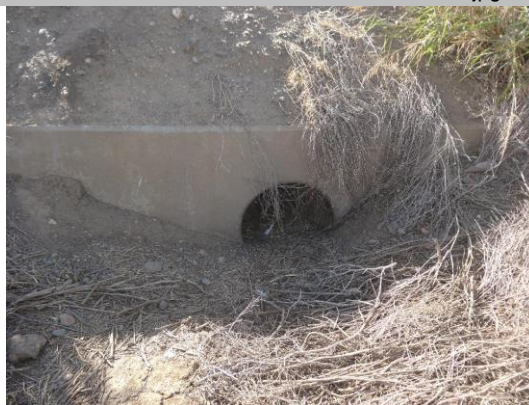
Photo 3 of 3 : UCIP_SP_2018_42993_35312.jpg

LS view: concrete headwall and CM pipe. Inlet needs cleaning. Part of inlet pipe buried.

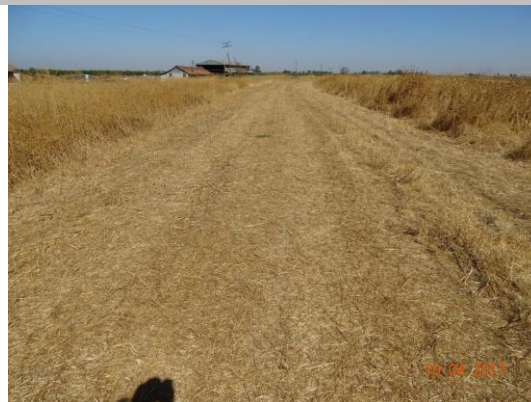
Photo 2 of 3 : SP_2018_NA0013_333_12_20180307_00003.jpg

Tall weeds cut LS and WS. (Fall 2017)

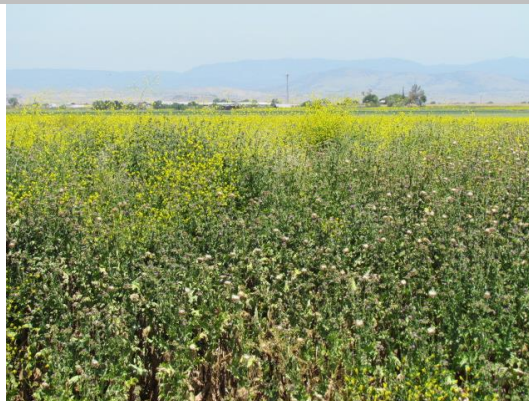
Photo 3 of 3 : SP_2018_NA0013_333_12_20180307_00002.jpg

Owens Creek levee mile 0.00 -1.40, unsatisfactory growth of weeds has completely taken over the levee section.(Spring 2017)

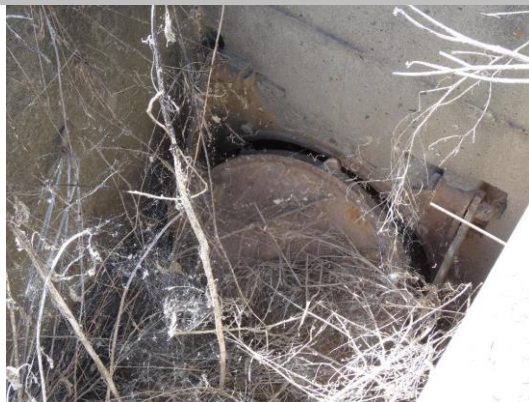
Photo 2 of 3 : UCIP_SP_2018_50144_35421.jpg

WS view: U typed concrete headwall, CM pipe, and flap gate. Damaged flap gate.

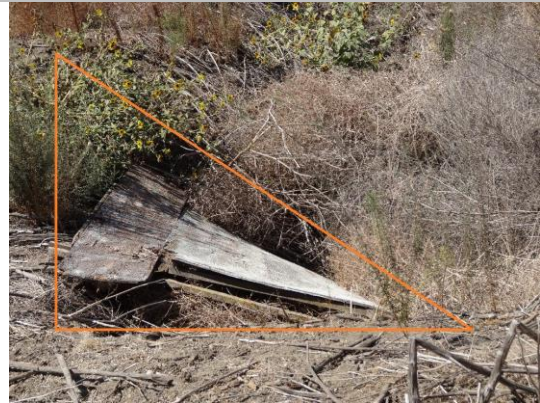
Photo 3 of 3 : UCIP_SP_2018_50144_35420.jpg

LS view: Debris dumped on inlet structure. Needs to be cleared or abandoned properly.

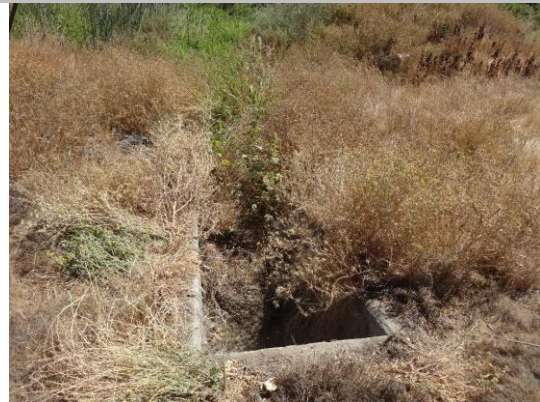
Photo 1 of 3 : UCIP_SP_2018_50149_35535.jpg

WS view: cobble spillway and channel on waterside. Dense vegetation on levee slope.

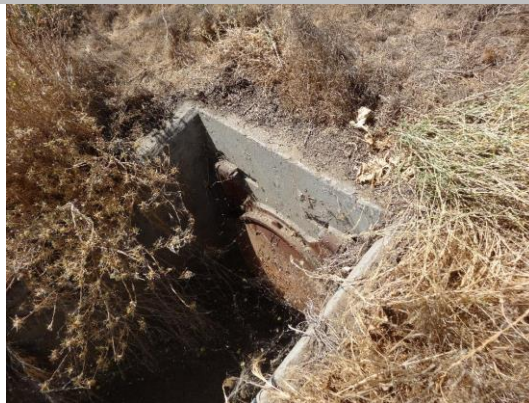
Photo 2 of 3 : UCIP_SP_2018_50149_35534.jpg

WS view: U typed concrete headwall, CM pipe, and flap gate. Vegetation needs to be cleared.

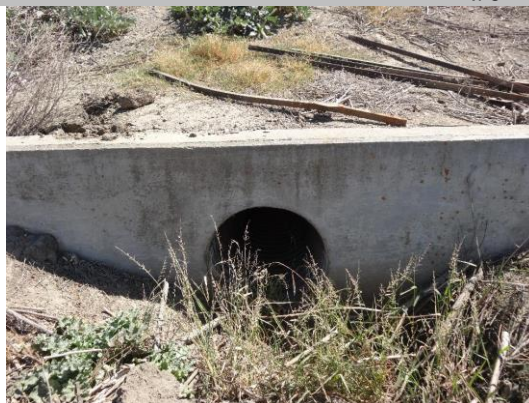
Photo 3 of 3 : UCIP_SP_2018_50149_35537.jpg

LS view: concrete headwall and CM pipe. Inlet needs clearing.

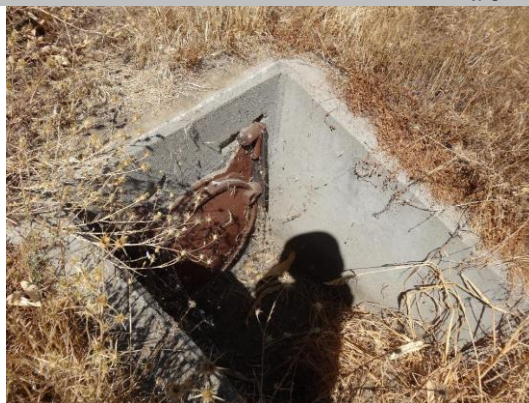
Photo 2 of 3 : UCIP_SP_2018_50151_35538.jpg

WS view: U typed concrete headwall, CM pipe, and flap gate. Vegetation needs to be cleared.

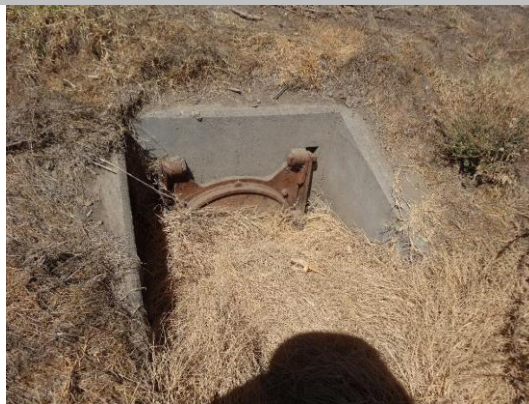
Photo 2 of 3 : UCIP_SP_2018_50152_35543.jpg

WS view: U typed concrete headwall, CM pipe, and flap gate. Vegetation needs to be cleared.

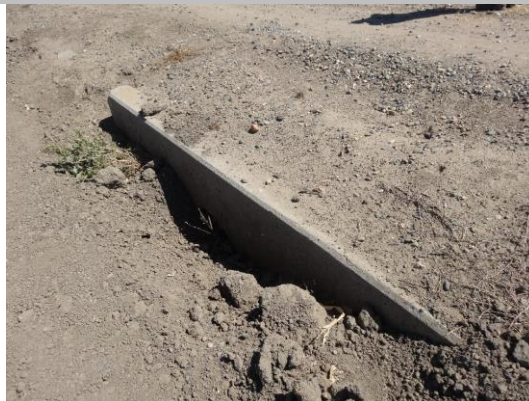
Photo 3 of 3 : UCIP_SP_2018_50152_35542.jpg

LS view: concrete headwall and CM pipe. Inlet needs clearing & cleaning.

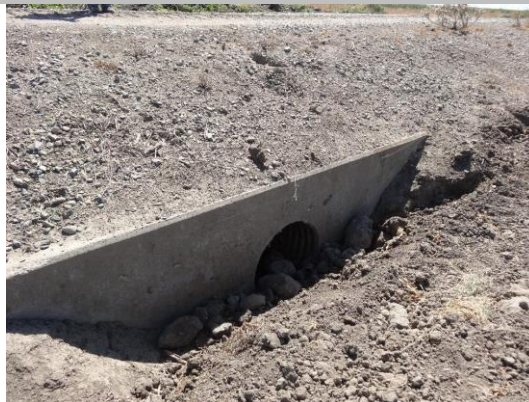
Photo 2 of 3 : UCIP_SP_2018_21063_35501.jpg

LS view: concrete headwall and CM pipe. Inlet needs clearing.

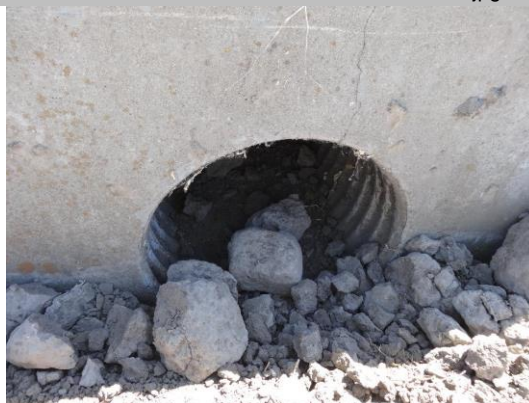
Photo 3 of 3 : UCIP_SP_2018_21063_35500.jpg

LS view: closer view of CM pipe. Inlet needs cleaning & clearing.

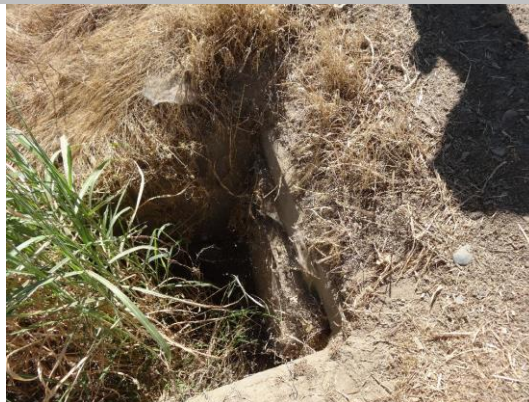
Photo 2 of 3 : UCIP_SP_2018_21064_35505.jpg

WS view: U typed concrete headwall, CM pipe, and flap gate. Vegetation needs to be cleared.

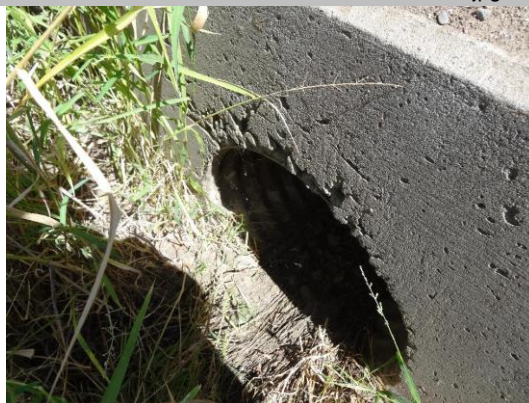
Photo 3 of 3 : UCIP_SP_2018_21064_35504.jpg

LS view: concrete headwall and CM pipe. Inlet needs clearing.

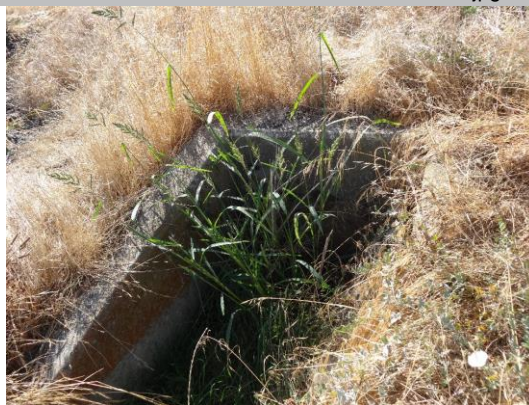
Photo 1 of 3 : UCIP_SP_2018_42991_35751.jpg

WS view: concrete spillway and channel on waterside. Dense vegetation on levee slope and spillway.

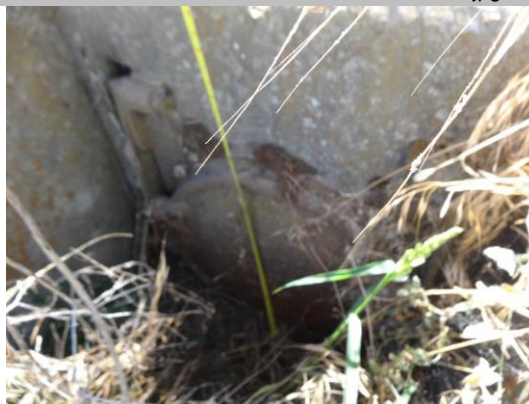
Photo 2 of 3 : UCIP_SP_2018_42991_35750.jpg

WS view: U typed concrete headwall, CM pipe, and flap gate. Vegetation and silt need to be cleared.

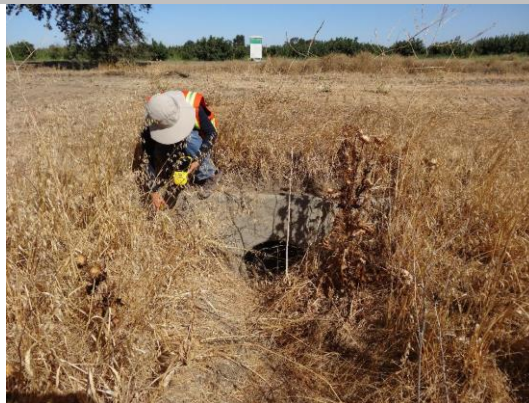
Photo 3 of 3 : UCIP_SP_2018_42991_35749.jpg

LS view: concrete headwall and CM pipe. Inlet silt needs clearing.

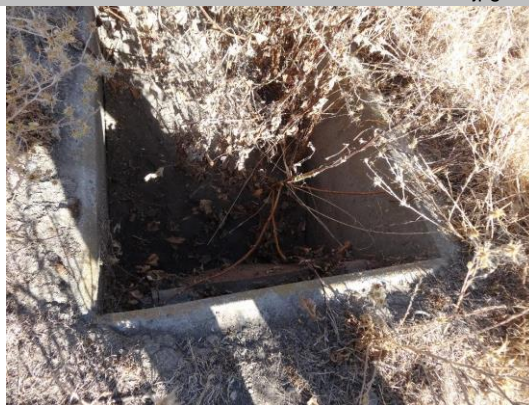
Photo 1 of 3 : UCIP_SP_2018_50146_35748.jpg

WS view: U typed concrete headwall, CM pipe, and flap gate. Vegetation needs to be cleared.

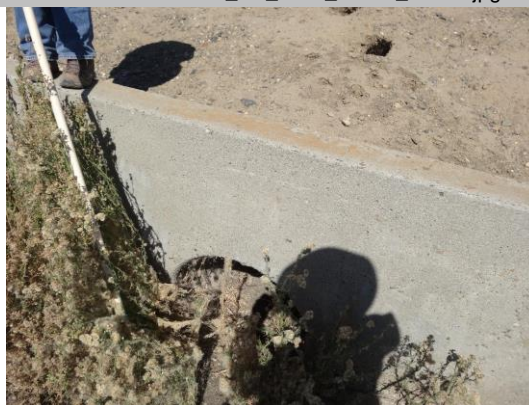
Photo 2 of 3 : UCIP_SP_2018_50146_35747.jpg

LS view: concrete headwall and CM pipe. Inlet needs clearing.

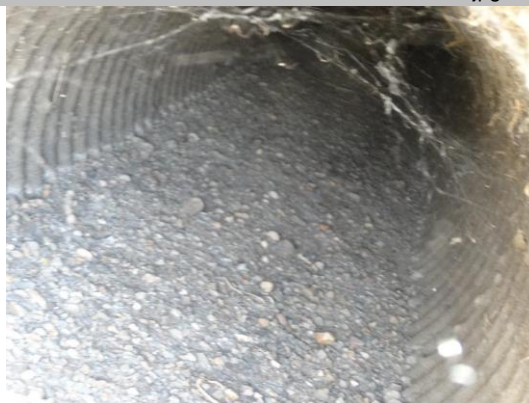
Photo 3 of 3 : UCIP_SP_2018_50146_35746.jpg

LS view: inside view of CM pipe. Inlet pipe needs clearing.

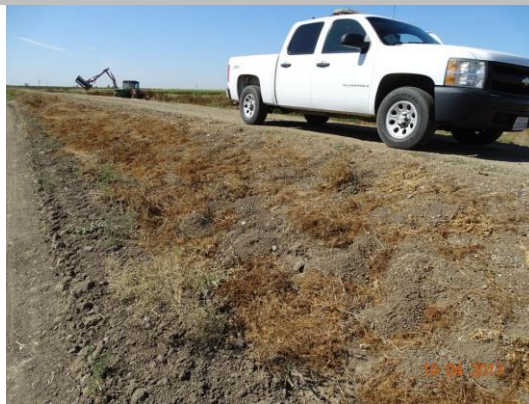
Photo 1 of 1 : SP_2018_NA0013_334_10_20180307_00001.jpg

Numerous rodent holes on LS slope.

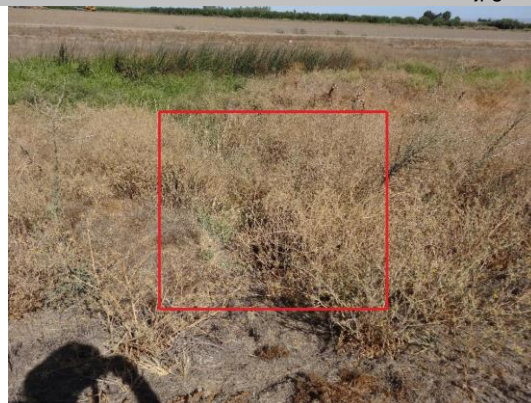
Photo 1 of 3 : UCIP_SP_2018_50154_35608.jpg

WS view: Dense vegetation on levee slope and spillway.

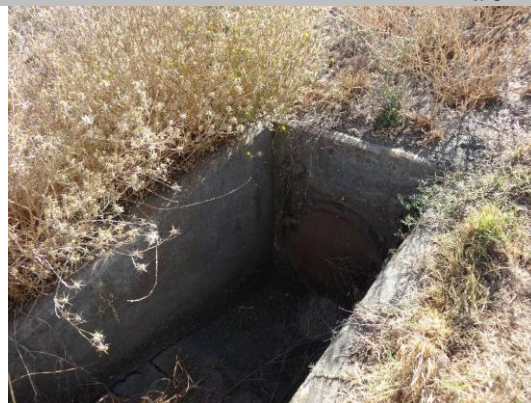
Photo 2 of 3 : UCIP_SP_2018_50154_35607.jpg

WS view: U typed concrete headwall, CM pipe, and flap gate. Vegetation needs to be cleared on spillway.

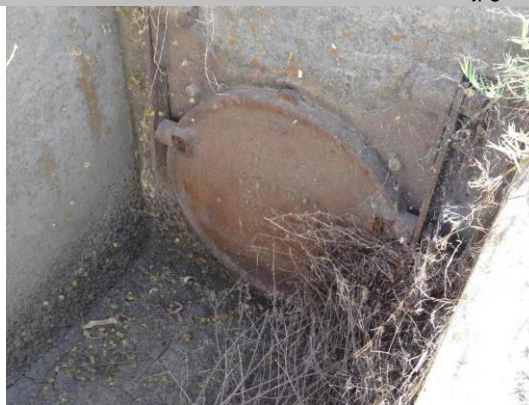
Photo 3 of 3 : UCIP_SP_2018_50154_35606.jpg

WS view: CM pipe and flap gate. Vegetation needs to be cleared.

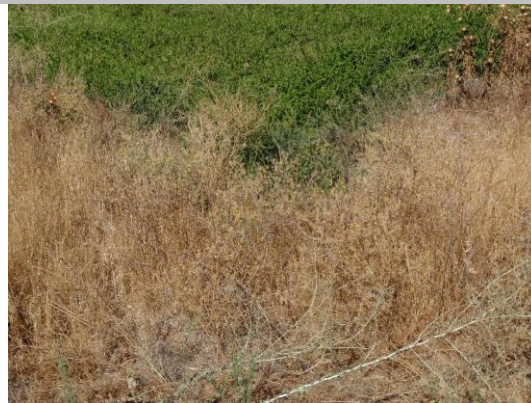
Photo 1 of 3 : UCIP_SP_2018_50155_35642.jpg

WS view: Dense vegetation on levee slope and spillway.

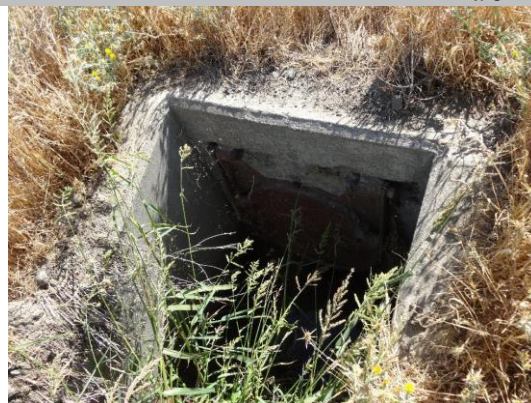
Photo 2 of 3 : UCIP_SP_2018_50155_35641.jpg

WS view: U typed concrete headwall, CM pipe, and flap gate. Vegetation needs to be cleared.

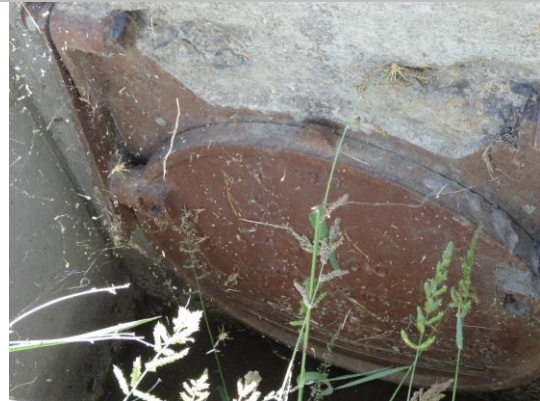
Photo 3 of 3 : UCIP_SP_2018_50155_35640.jpg

WS view: CM pipe and flap gate. Vegetation needs to be cleared.

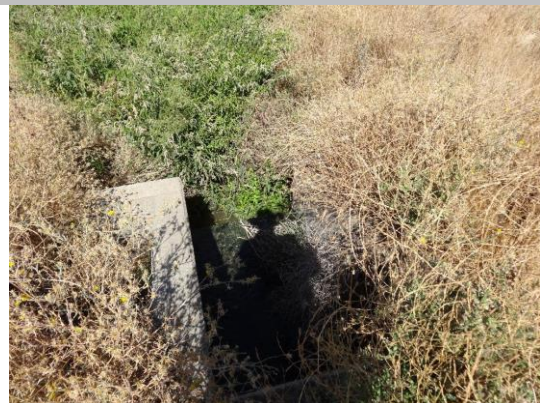
Photo 1 of 3 : UCIP_SP_2018_21126_35652.jpg

WS view: concrete spillway and channel on waterside. Dense vegetation on levee slope and spillway.

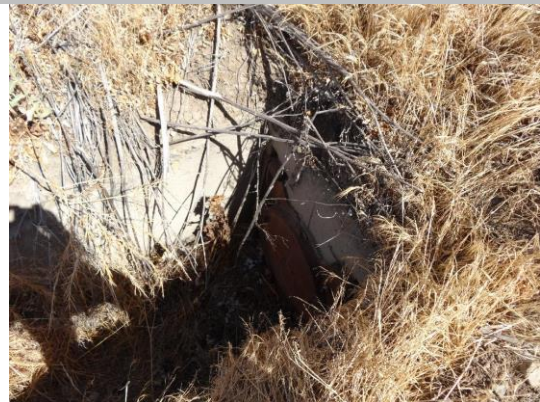
Photo 1 of 3 : UCIP_SP_2018_21210_35709.jpg

WS view: concrete spillway and channel on waterside. Dense vegetation on levee slope and spillway.

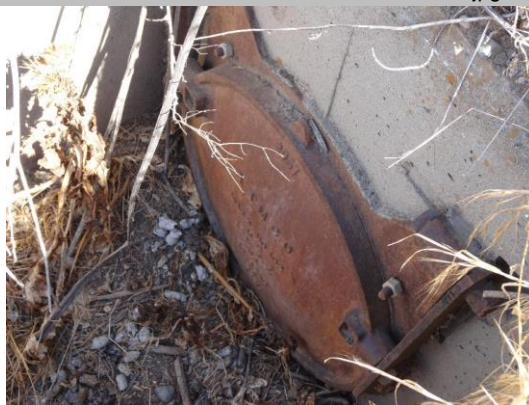
Photo 2 of 3 : UCIP_SP_2018_21210_35708.jpg

WS view: U typed concrete headwall, CM pipe, and flap gate. Spillway needs to be cleared.

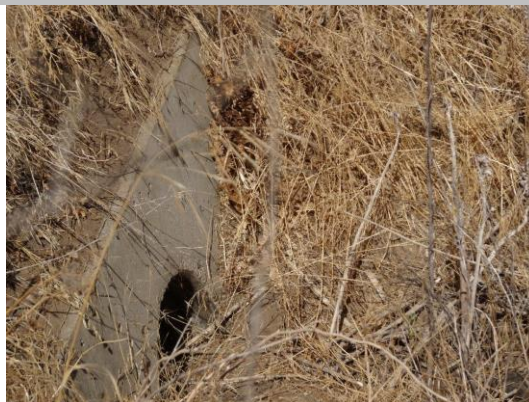
Photo 3 of 3 : UCIP_SP_2018_21210_35707.jpg

LS view: concrete headwall and CM pipe. Inlet silt needs clearing.

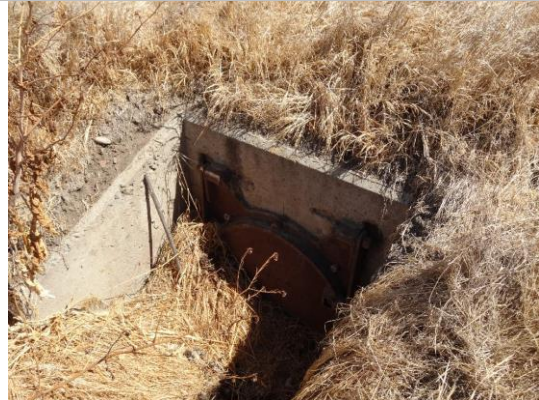
Photo 1 of 3 : UCIP_SP_2018_50153_35745.jpg

WS view: U typed concrete headwall, CM pipe, and flap gate. Dirt and vegetations need to be removed and cleared.

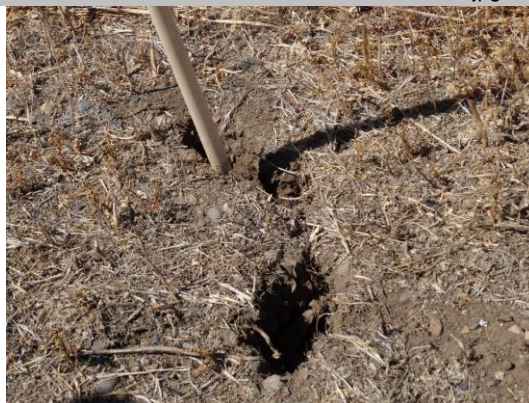
Photo 2 of 3 : UCIP_SP_2018_50153_35744.jpg

WS view: significant levee cracks along the pipealignment. Needs detailed investigation on the issue.

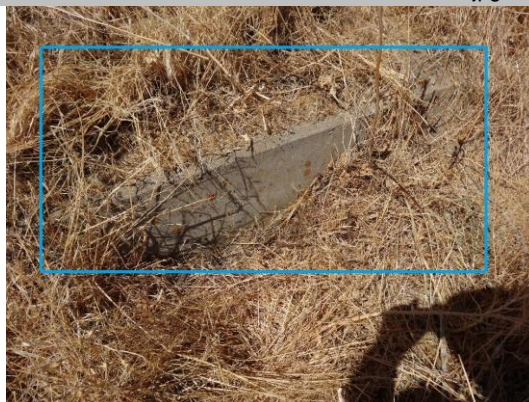
Photo 3 of 3 : UCIP_SP_2018_50153_35743.jpg

LS view: concrete headwall and buried CM pipe. Dirt removal and clearing needed in inlet.
